**OFFICE OF THE AUDITOR GENERAL**

**STATUS REPORT ON THE FOLLOW UP OF THE**  
**ENGINEERING AUDIT OF CHOGM ROAD**  
**WORKS UNDERTAKEN BY THE MINISTRY OF**  
**WORKS & TRANSPORT AS AT**  
**19<sup>TH</sup> FEBRUARY, 2009**

**FINAL REPORT ON THE FOLLOW UP OF THE ENGINEERING  
AUDIT OF CHOGM ROAD WORKS UNDERTAKEN  
BY THE MINISTRY OF WORKS & TRANSPORT  
AS AT 19<sup>TH</sup> FEBRUARY, 2009:**

CHOGM ACTIVITIES BY MoWT IN PICTURES – STATUS AS AT  
19<sup>TH</sup> FEBRUARY 2009

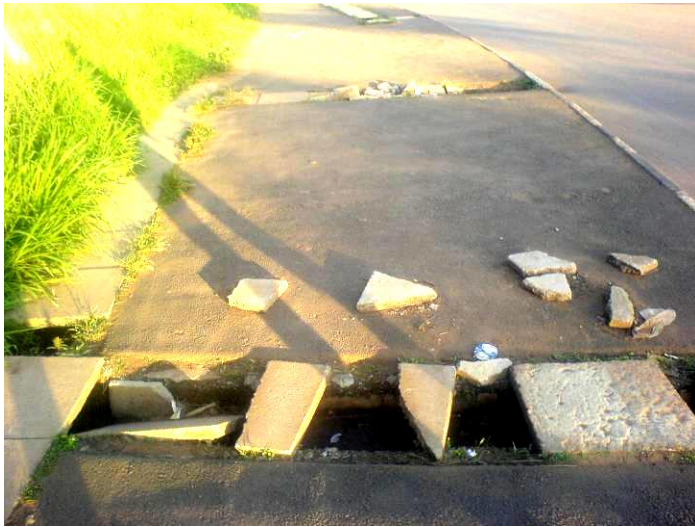
1.	Energo ltd	Package 1 lot 1: kibuye-zana, zana-Entebbe airport, Aki Bua, Binayomba	<p>a) Installation of 118 sq.m of pre-cast slabs near Lido Beach and ministry of works h/q or recovery of UGX. 15 Million.</p> <p>b) Surface dressing-2<sup>nd</sup> seal estimated at 35407 sq.m should be verified. Alternatively recovery of UGX. 231.87 million be made.</p>	<p>a) The shortfall of precast slabs is 92.4 m<sup>2</sup> equivalent to UGX 12,474,000 shall be recovered in the Final Account.</p> <p>b) The shortfall in surface dressing of 2929.7 sq.m equivalent to Shs.12,459,410 shall be deducted in the final account.</p>	<p>a) Field inspection revealed 70.85 sq.m instead of 89.6sq.m of pre-cast slabs at Lido Beach. At the ministry of works, only 36 sq.m of slabs were verified compared to the requirement of 90 sq.m . The rest were found either broken or under overgrown bush. It was explained that some slabs were stolen. In the circumstances, recovery of UGX.12,474,000 is considered adequate remedy.</p> <p>b) Five (5) junctions along Zana-Entebbe road were re-measured jointly and found to correspond to the measurement sheets of the consultant.. The variance of 2,929.7 sq.m equivalent to</p>

**Picture 1:** Pre-cast slabs near MoWT offices on Zana – Entebbe Rd. Note the poor quality of slabs due to lack of steel reinforcement. (EnergO/ MBW)

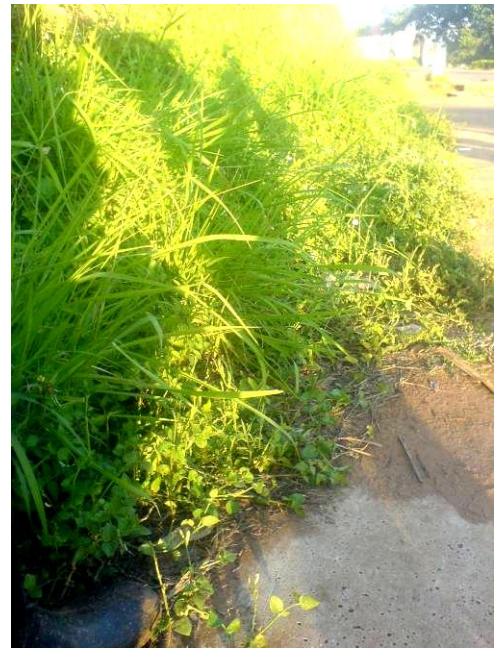
**Picture 2:** Pre-cast slabs near MoWT offices on Zana – Entebbe Rd could not be ascertained due to overgrown bush on top. (EnergO/ MBW)

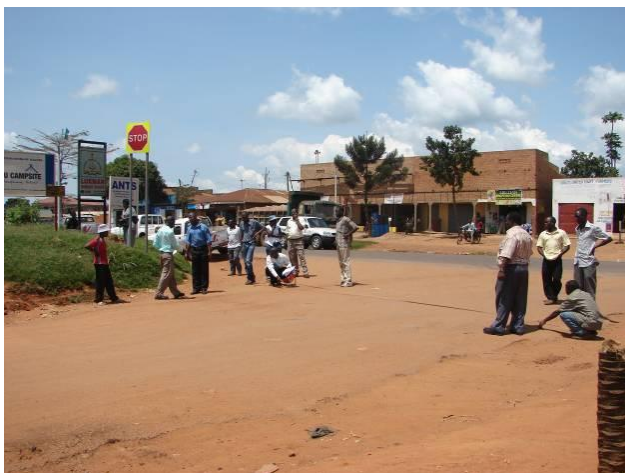
2. Jointly verify surface dressing at Junctions or recover shs. 231.87 m.	2. Joint verification found most junctions dressed. Shs. 12,459,410 agreed recoverable.	2. Shs. 12,459,410 to be recovered in final account.	2. As above.

**Picture 3:** Measuring of junctions to ascertain surface dressing quantities on Zana - Entebbe Rd. (EnergO Ltd/ MBW)

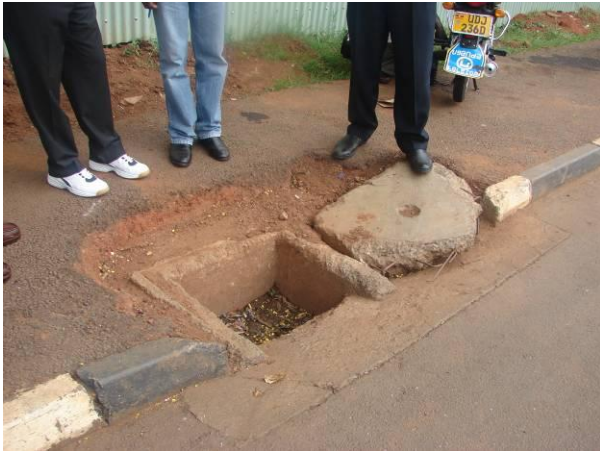
smaller stone chippings and paid under second seal item.	first seal was verified and considered satisfactory.
3.	Stirling Civil Engineers	Package 2 lot 1: Queen's way, Kampala road, MacKinnon road. Jinja Rd. An addendum with 30 roads was made.	<p>a) PPDPA authority for additional works worth Shs.5,001,567,515 (134% of original contract) not provided.</p> <p>b) Pothole patching and walkways not finished on Nehru, Ternan Avenue, Katonga Rd, Hannington Rd, Kagera Rd, Apollo Kagwa Rd and Princess Avenue.</p>	<p>a) PPDPA clearance is still being sought.</p> <p>b) The delay to complete the works is attributed to contractor's poor cash flow due to unpaid certificates. The unpaid certificates are; certificate No. 5, 6 and 7</p>	<p>a) PPDPA authority was not availed.</p> <p>b) The uncompleted works are attributed to non payment for certificates 5, 6 and 7. Field inspection revealed the following on the Kampala inner roads:  <b>Dewinton road:</b>  Manhole covers were not put in place and the drainage is blocked. Picture no.5 refers.  Walk way failures: see picture no.6.</p>

**Picture 5:** “Other Kampala Inner Roads” Dewinton Rd. Drainage blocked due to lack of Manhole covers. (Stirling/ KOM)

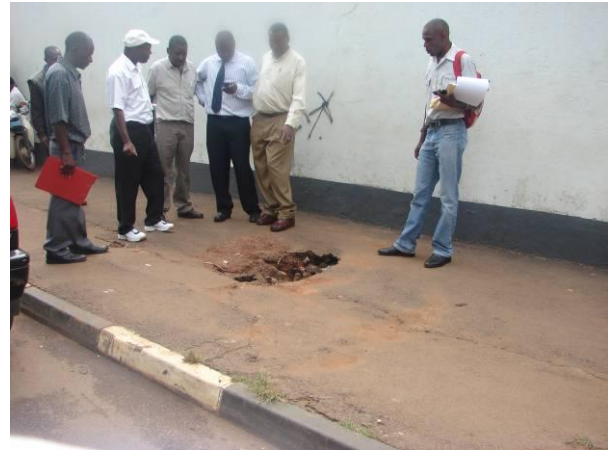
**Picture 6:** Pavement failure on the Walkways on Dewinton Road

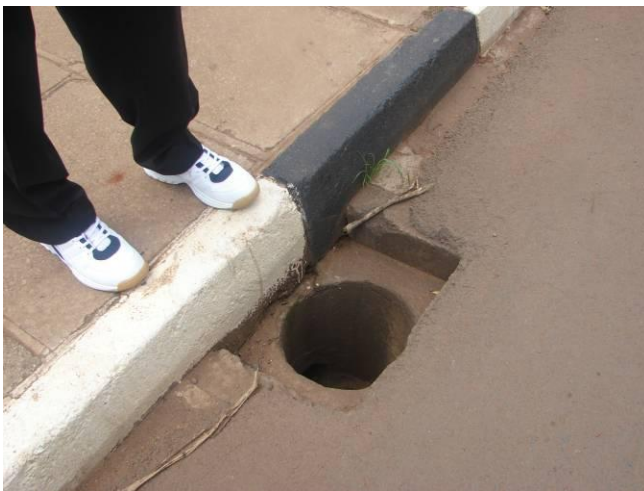
**Picture 7:** Steel Gratings missing, are dangerous to pedestrians and will cause blockage. Nile Avenue “Other Kampala Inner zone Rds - Stirling /KOM

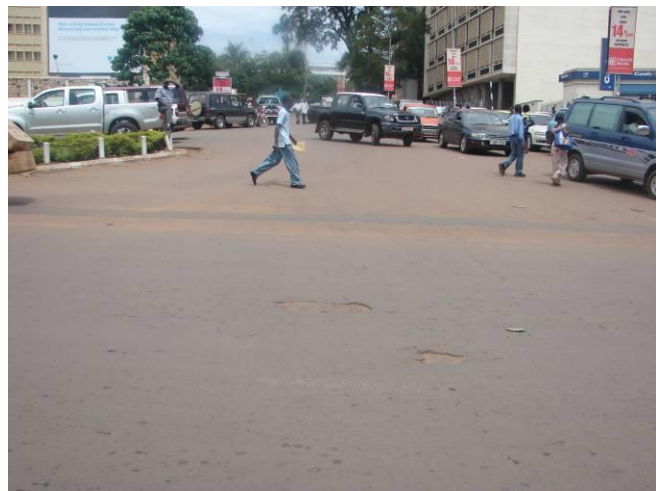
**Picture 8:** Road failure of the overlay on Kampala – Jinja Rd near the Junction to Embassy House - Stirling /KOM

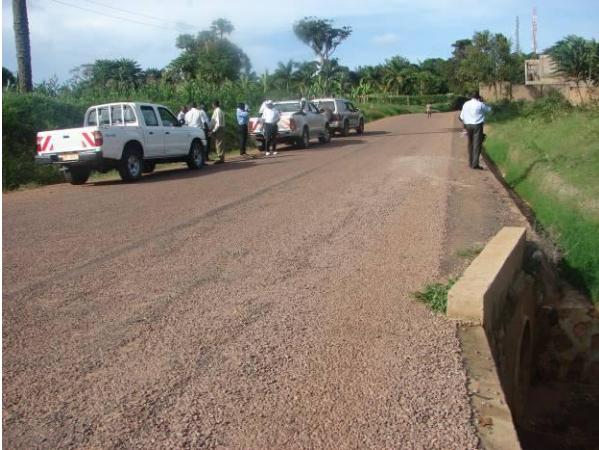
**Picture 9:** Lukuli – Buziga – Munyonyo Rd after completion. (Mulowoza/M&E Assoc.)

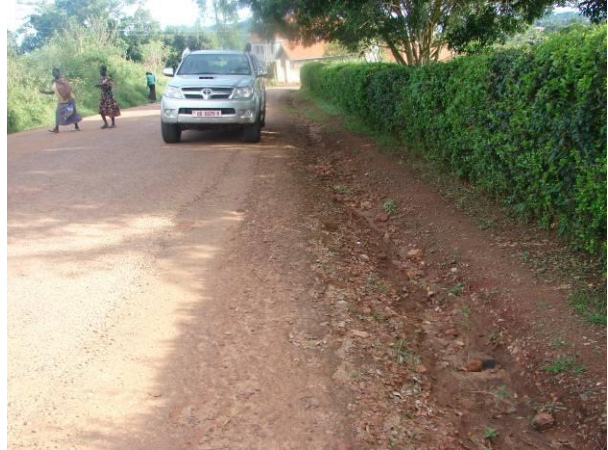
7.	Mulwooza brothers	Package 4 lot 1: Lukuli-Buziga - Munyonyo	a) No progress report seen. b) Works were progressing very slowly. c) Close supervision was recommended.	<ul style="list-style-type: none"> <li>Works substantially completed on 15/12/08. Consultants supervised the works to completion. MOW&amp;T to supervise outstanding works in the Defects Liability Period.</li> </ul>	a) Field inspection revealed substantial completion in accordance with designs. However it was noted that the scope of works excluded drainage in some sections which will result into road deterioration.  b) Management needs to submit

**Picture 10:** Lukuli – Buziga – Munyonyo Rd. lack of drainage intervention in the design scope. (Mulowoza/M&E Assoc.)

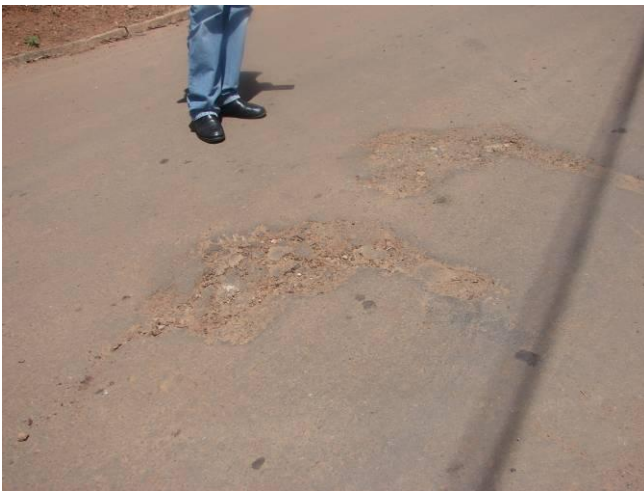
**Picture 11:** Road failure noted on the asphalt overlay on Elizabeth Road

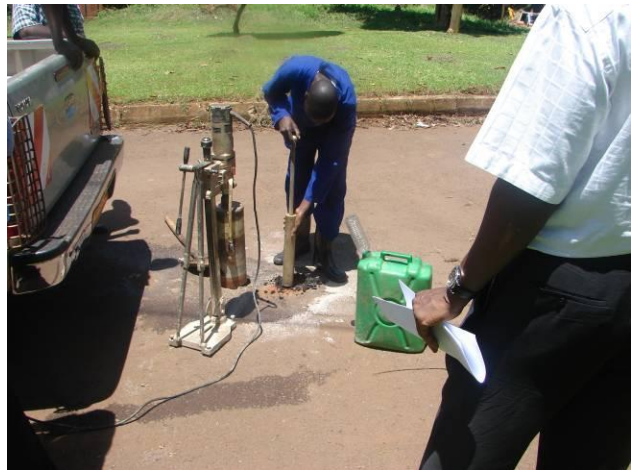
**Picture 12:** Coring to test asphalt quality on Philip Road. Spenco/PROME

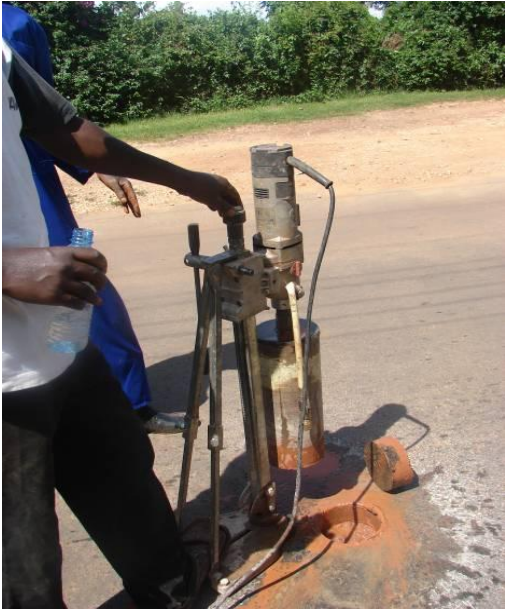
Prince Charles Drive	<p>have it done.</p> <ul style="list-style-type: none"> <li>• Drainage works not done.</li> </ul>	<p>drainage and storm water system required complete rehabilitation which could not be addressed under the contract.</p> <ul style="list-style-type: none"> <li>➤ Drainage cleaning was therefore executed by Road Cleaners included under Variation Order No.2 to the works contract.</li> <li>➤ The contract has never been paid for cleaning of drainage on Mabua Road, other than for the drainage cleaning done by the Road Cleaners.</li> </ul> <p><b>Prince Charles Drive</b></p> <ul style="list-style-type: none"> <li>➤ Surface dressing was done on Elizabeth Avenue and not Prince Charles. The 2<sup>nd</sup> Seal has since been laid.</li> </ul>	<p>2. Variation order no.2 still awaited.</p> <p>1. The average thickness of the core was 48mm which was comparable to the design of 40mm.</p>

**Picture 13:** Coring to test asphalt quality and thickness on Prince Charles Drive. (Spenco/ PROME)

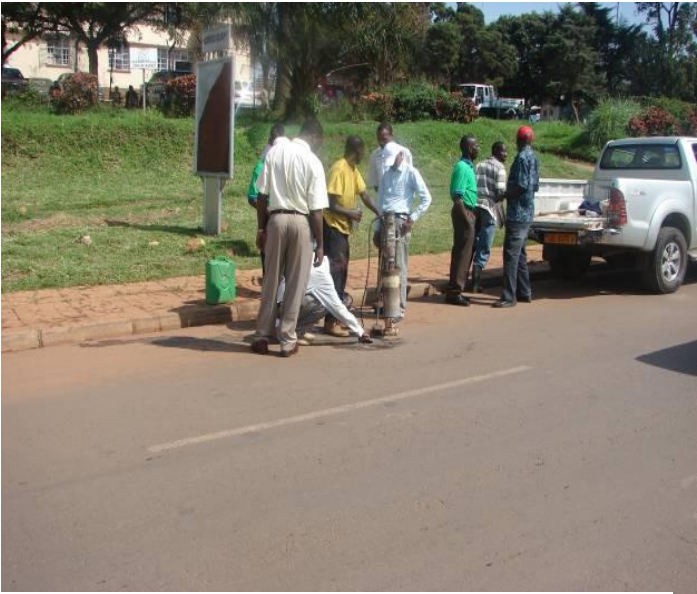
**Picture 14:** Coring to test asphalt concrete thickness and quality. Jinja Rd near Police Station. (Cementers/ PROME)

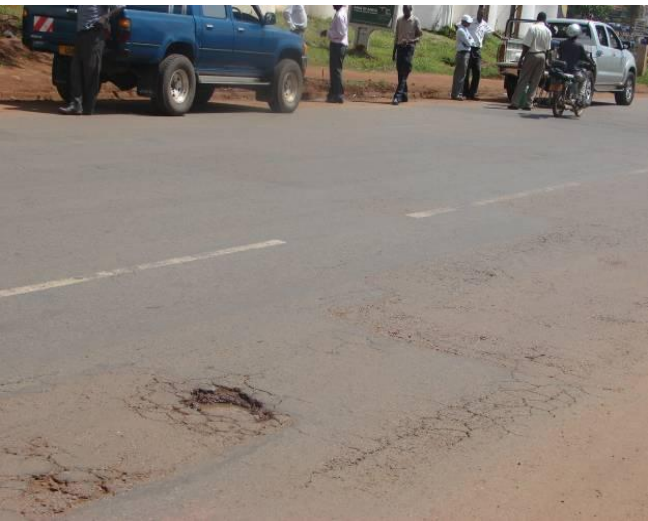
**Picture 15:** Failure of the patching . Jinja Rd near Lugogo Indoor Stadium. (Cementers/ PROME)

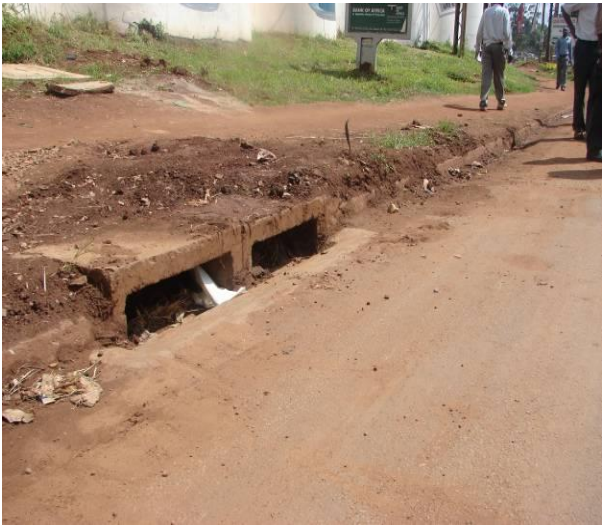
**Picture 16:** Poor drainage maintenance. Jinja Rd near Lugogo Indoor Stadium (Cementers/ PROME)

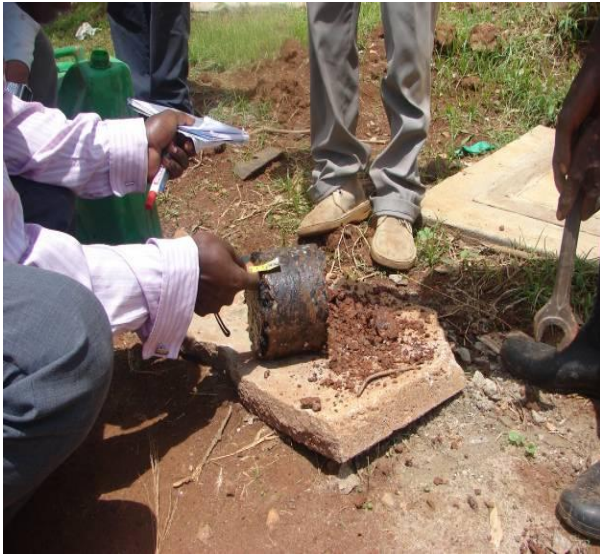
**Picture 17:** Measuring the thickness of the asphalt core. Jinja Rd near Lugogo Indoor Stadium. (Cementers/ PROME)

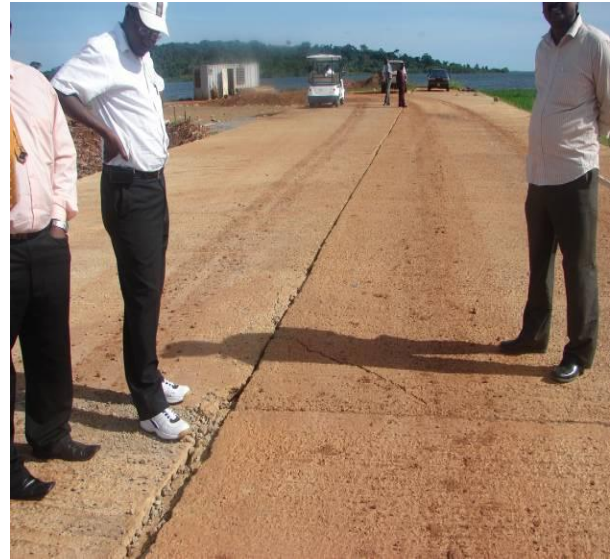
<b>Munyonyo Marina</b>	1. 88.4 cubic m. of concrete had been over paid. Shs.44m was recoverable.	1. Works should be completed or payments recovered.	1. Works had been re-started and to be completed by end of	Site verification in February 2009 revealed on going

<p>2.506m of guard rails had been over paid without installation. Shs. 56m was recoverable.</p> <p>3. Expansion joints were widening and needed to be stabilized.</p> <p>4. Temporary dredging fingers were found under use for docking boats yet this was dangerous.</p>	<p>2. Guard rails be installed or recovery be made.</p> <p>3. The joints should be stabilized.</p> <p>4. Usage of dredging fingers be stopped to avoid accidents.</p>	<p>March 2009</p> <p>2. Installation of guar rails had resumed and to be completed by end of March 2009.</p> <p>3. The joints had stabilized.</p> <p>4. The private operator had rejected advise of non –use of the temporary fingers claiming he will take full responsibility</p>	<p>concrete works and installation of guard rails. A comprehensive review shall be undertaken after completion of all works.</p>
--	---	---	---	--

**Picture 18:** Casting concrete, expansion joints and installation of guardrails still on going. Munyonyo – Marina – Spencon/PROME

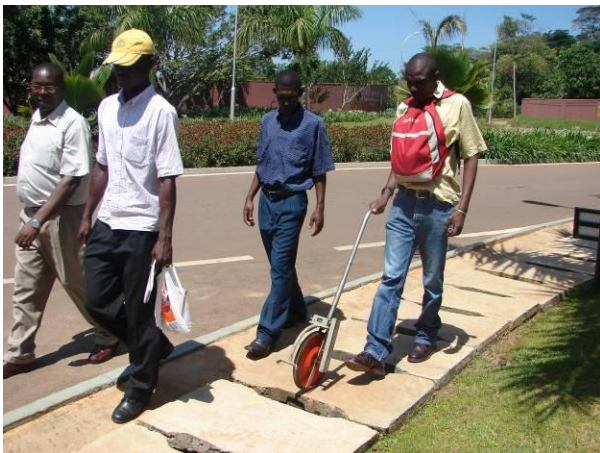
**Picture 19:** Munyonyo CWR driveway and parking. Note lined drains and covers 620×970×75mm. (Dott Services/ MoWT)

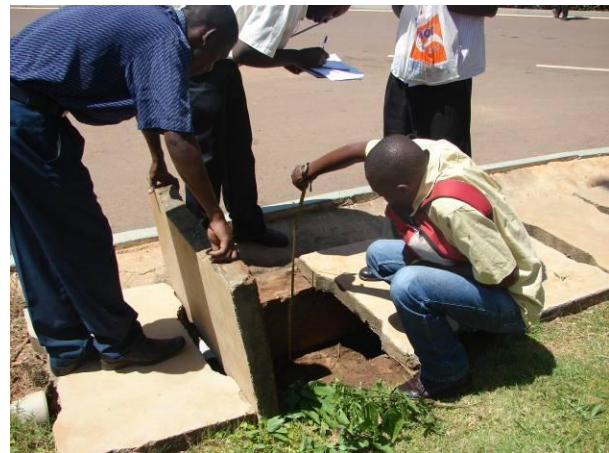
2.7 Concrete slabs 14.8m	<p>Item 2.7 The corrected quantity is 592 and the difference between paid quantity and corrected quantity is 148 No. The recovered amount is Shs.14.8 million.</p>	<p>Item 2.7 The verified number of concrete slabs (620*970*75 mm) was 541. The recoverable amount is Shs.19,900,000.</p>
			4.2 Provide sand : 15m	<p>Item 4.2 Physical qty is 18,500 sm. The difference of 4,195 sqm between paid qty and physical qty was redone qty.</p>	<p>Item 4.2 The ministry should seek for recovery from Speke Resort, Munyonyo.</p>
			4.3 Paving blocks : 383m	<p>Item 4.3 Physical qty is 18,500 m<sup>2</sup>. The difference of 4,195 m<sup>2</sup> is the quantity that was redone in October 2007 due to damaging of the already laid</p>	<p>Item 4.3 The ministry should seek recovery from Speke Resort Ltd.</p>

**Picture 20:** Munyonyo CWR driveway and parking. Measurement of lined drains and covers 620×970×75mm. (Dott Services/ MoWT)

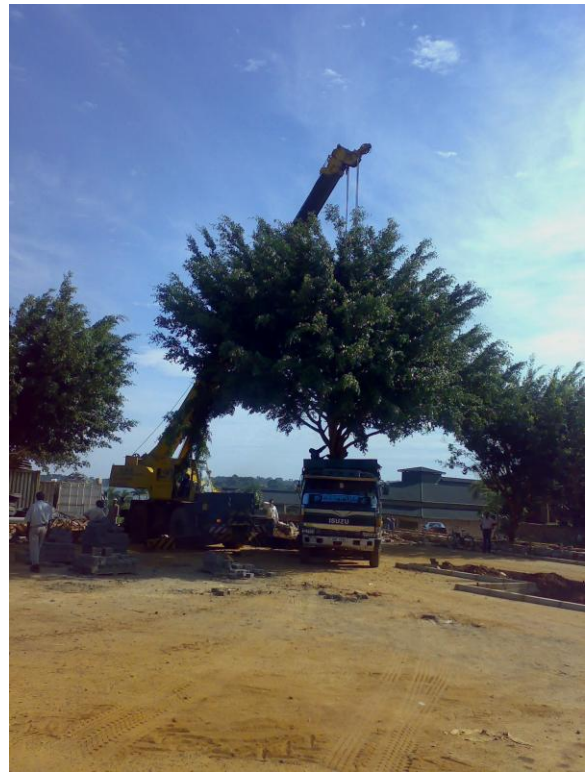
**Picture 22**

**Pictures 21, 22 and 23:** Munyonyo CWR driveways and parking. Paving blocks were reported broken (picture 21) by other contractors (Picture 22) and new ones re-laid (picture 23) at the expense of MoWT.

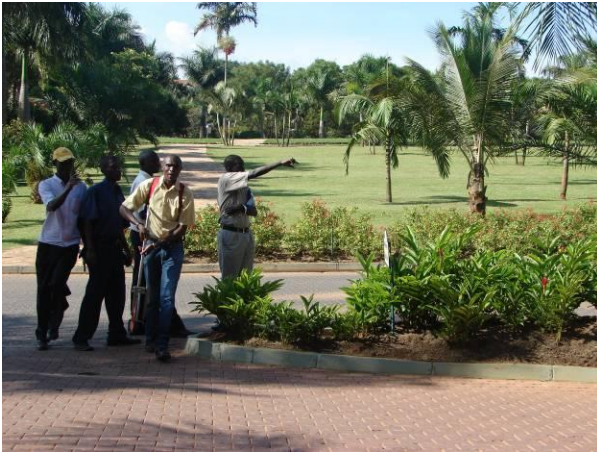
**Picture 24:** Munyonyo CWR driveway and parking. Verification of road Kerbs. (Dott Services/ MoWT)

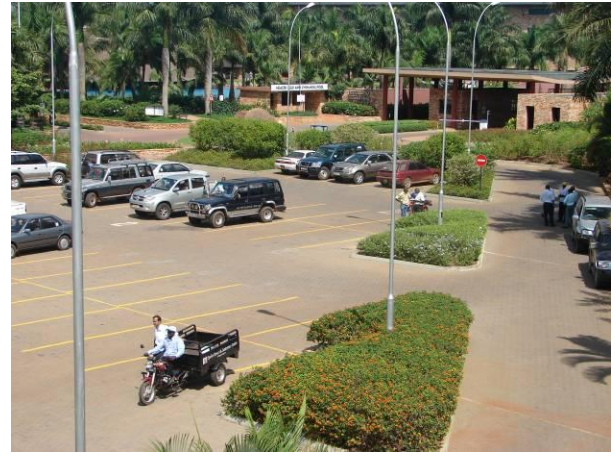
4.8 Asphalt : 34m	<p>paving blocks by unidentified contractors.</p> <p>Item 4.8 The corrected quantity is 15,451 m<sup>2</sup> and the difference between paid quantity and corrected quantity is 564 m<sup>2</sup>. The recovered amount is UGX. 36.660 million</p>	<p>Item 4.8 We await submission of final account for verification.</p>
			4.9 Road kerbs 25.3m	<p>Item 4.9 The corrected quantity is 5,175 m which is 553 m more than the paid quantity. The additional amount to the contractor is Shs.45.1248 million.</p>	<p>Item 4.9 Joint verification revealed 5,504 .77 m.</p>
			5.0 Main Entrance Canopy 489m	<p>Item 5.0 The Engineer's Estimate for</p>	<p>Item 5.0 Recoverable amounts now</p>

the main entrance and gate house was UGX 485 million (copy attached in Annex B57C).	estimated at Shs.103 million.
--	--	--	--	---	-------------------------------

**Picture 25:** Munyonyo CWR driveway and parking. Note entrance/canopy house showing the three units of housing and roof. (Dott Services/ MoWT)

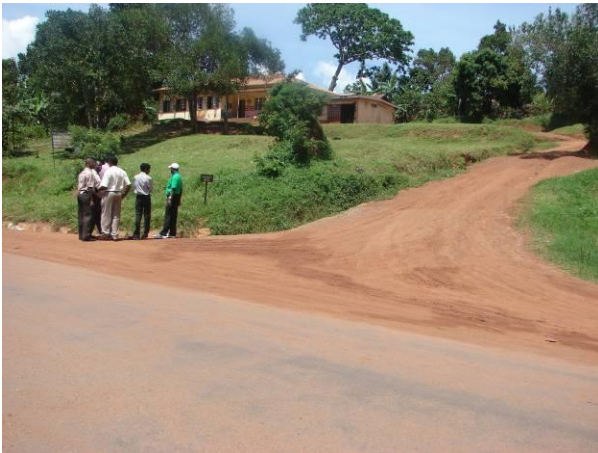
2.	Dott Services ltd	Package 1 lot 2: Salaama road	<p>a) PPDPA clearance for additional works worth UGX. 2,858,623,270 (132% of original contract) not provided.</p> <p>b) 1<sup>st</sup> sealing at junctions not provided.</p>	<p>a) PPDPA clearance was not obtained.</p> <p>b) The 1<sup>st</sup> Seal at junctions was provided using</p>	<p>a) PPDPA clearance not availed.</p> <p>b) The assertion of use of smaller stones and chippings in lieu of</p>

**Picture 26:** 2<sup>nd</sup> sealing at road junctions. Salaama Rd. Note the silting. (Dott Services/ MBW)

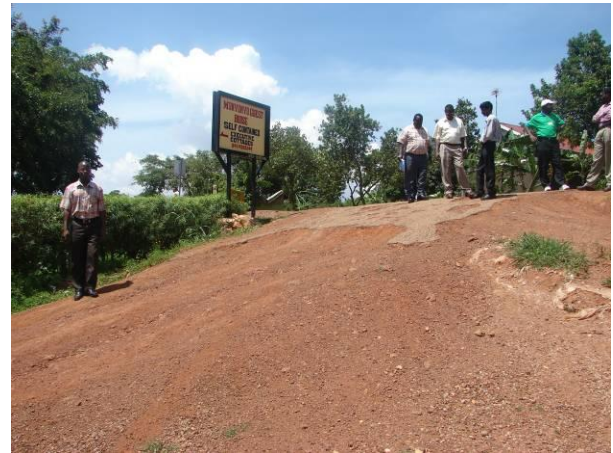
**Picture 27:** 2<sup>nd</sup> sealing at road junctions. Salaama Rd.. (Dott Services/ MBW)

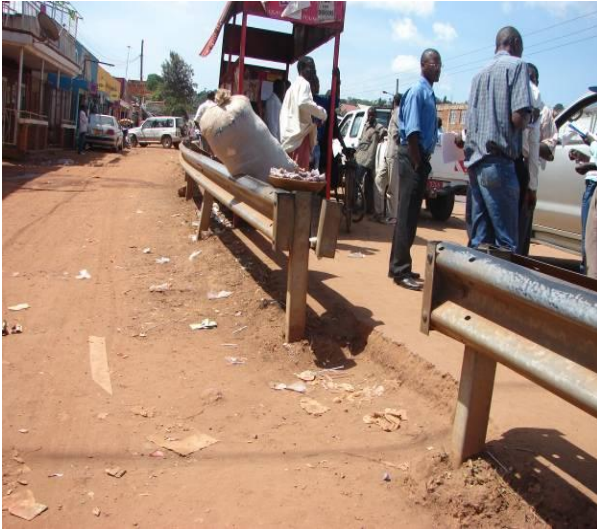
3. Re-measure guard rails.	3. 74.7m of guard rails found missing.	3. Shs. 18,450,900 to be recovered in	3. As above.

**Picture 28:** Counting of guardrails at Kajjansi on Zana - Entebbe Rd. (Energo Ltd/ MBW)

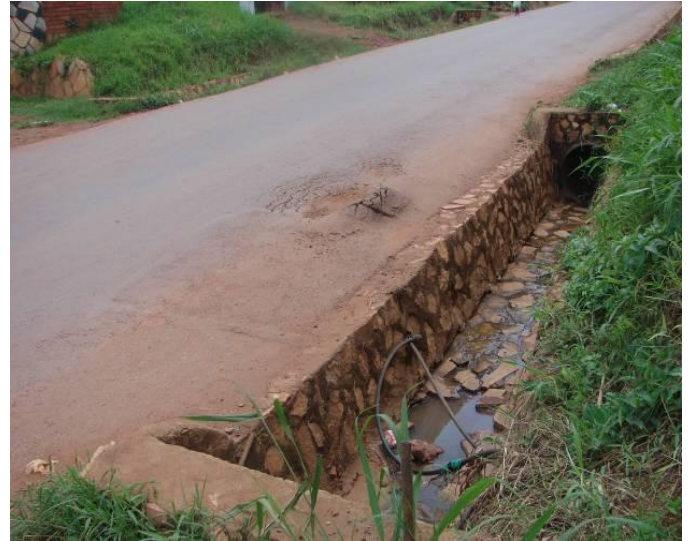
**Picture 29:** Road failure of asphalt concrete due to water connection leakage after road works. Kyadondo II (Dott/ KAGGA)

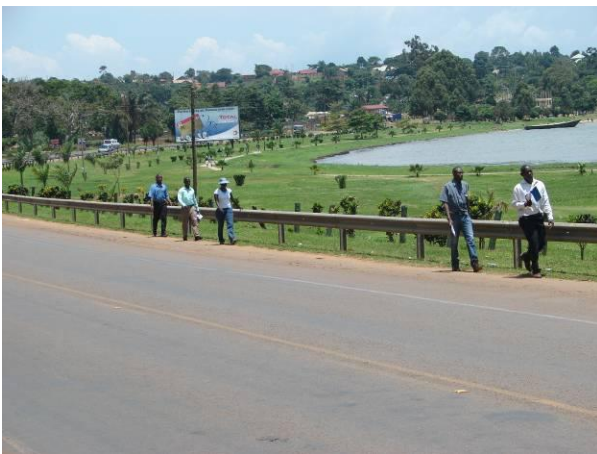
**Picture 30:** Counting of guardrails at Kitubulu on Zana - Entebbe Rd. (Energo Ltd/ MBW)

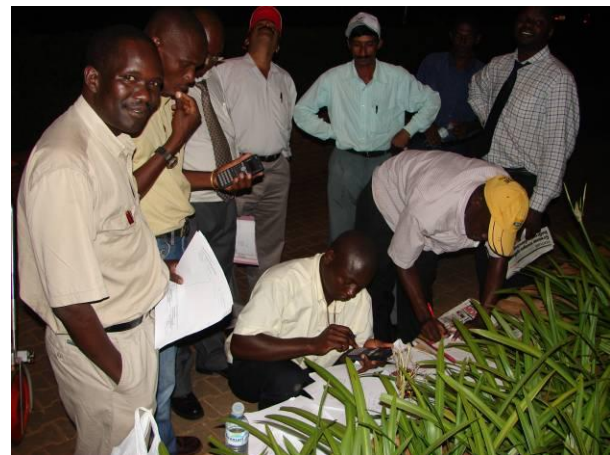
**Picture 31:** Munyonyo CWR driveway and parking. Auditors, MoWT, and Contractor finalizing a site investigation report at 8:20pm 17- 02 - 09. (Dott Services/ MoWT)
