**Office of the Auditor General**

**VALUE FOR MONEY AUDIT REPORT  
ON DISTRIBUTION OF WATER TO URBAN AREAS BY  
NATIONAL WATER AND SEWERAGE CORPORATION**

**Prepared By  
Office Of The Auditor-General  
P.O. Box 7083  
Kampala**

***February, 2009***

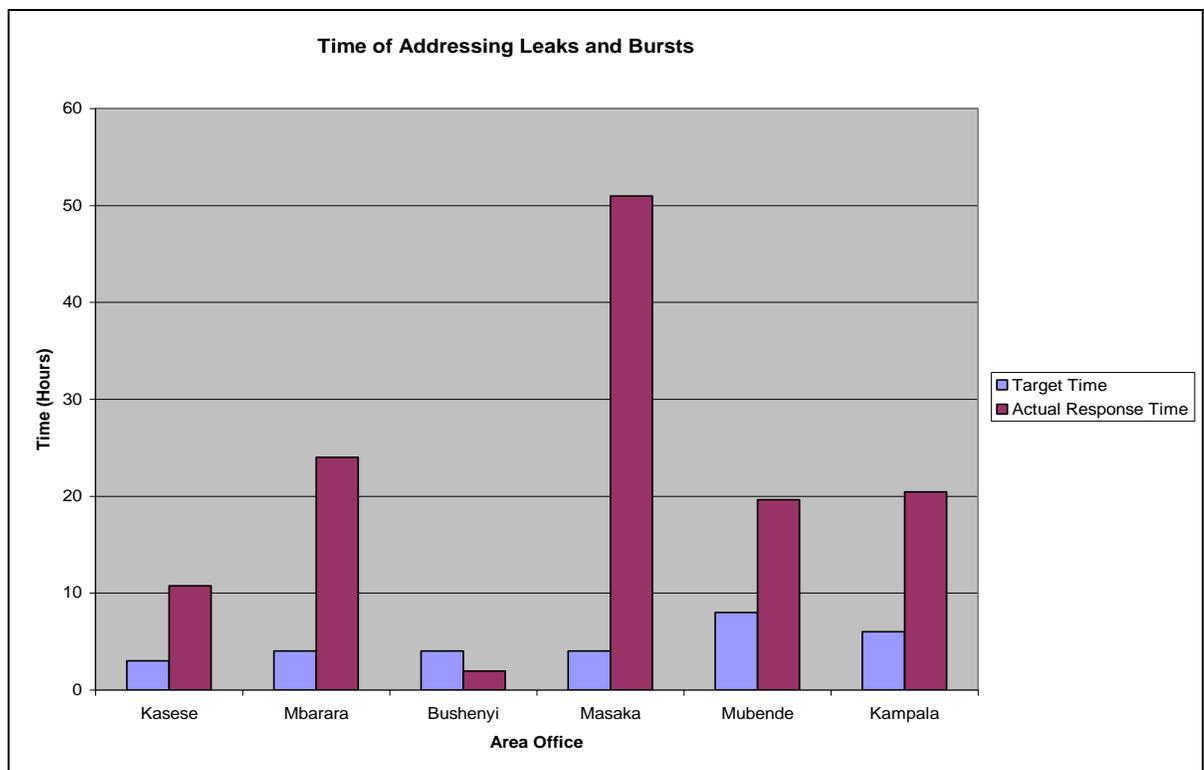
We noted that in different area offices, response time for addressing leaks and bursts on mains and service lines is at an average of 2 hours to 50 hours based on available data as shown in the graph below.

While it takes on average 10 hours or less in areas like Kasese and Bushenyi, in bigger operational areas like Mbarara, Masaka and Kampala it takes on average 20 hours or more to rectify these faults.

The delays are mainly caused by shortage of repair materials like delays caused by the centralized procurement system and Area offices storing materials for addressing simple leakages while materials for major repairs would be requisitioned from headquarters. To mitigate this bottleneck, management of NWSC has now given the autonomy to areas to procure all repair materials under the IDAMC.

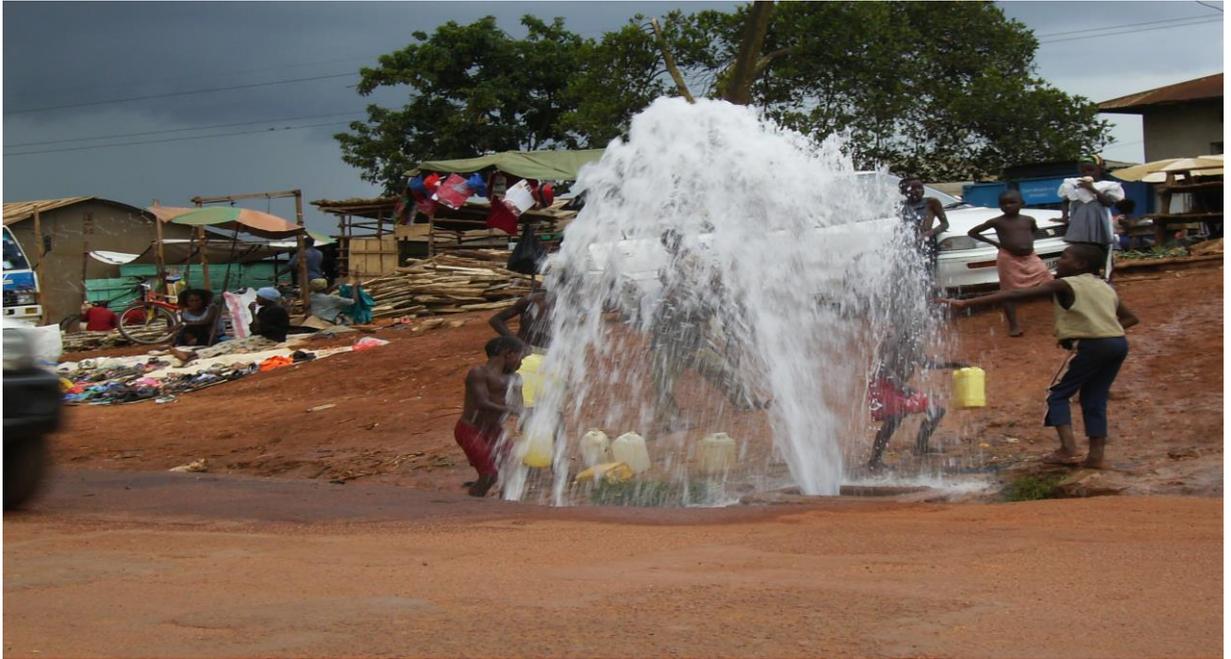
Buried valves also take long to excavate and in the process this increases water losses. Besides, locations of the valves are in many cases known to only few staff members. For performance efficiency, management is training area technical staff under the QMS [ISO certification programme], to improve on network operations and maintenance activities.

*Water gushes out along Busega round-about FH on 21<sup>st</sup> January 2008 3:38pm.*

These delays translate into huge amounts of water losses especially on the water mains which distribute substantial amounts at high pressure (like the picture above). NRW for all areas stood at an average of 32.5% as at 30<sup>th</sup> June 2007 while in Kampala area alone, NRW was at an average of 38.5%<sup>7</sup>. This is considered high compared to 20% acceptable for developing countries and the Corporations target of 28.7%.

- (i) A map of all key points like valves should be availed to staff in charge of operations/maintenance to ease their work. Staff should be regularly inducted and trained to acquaint themselves with the locations of valves.

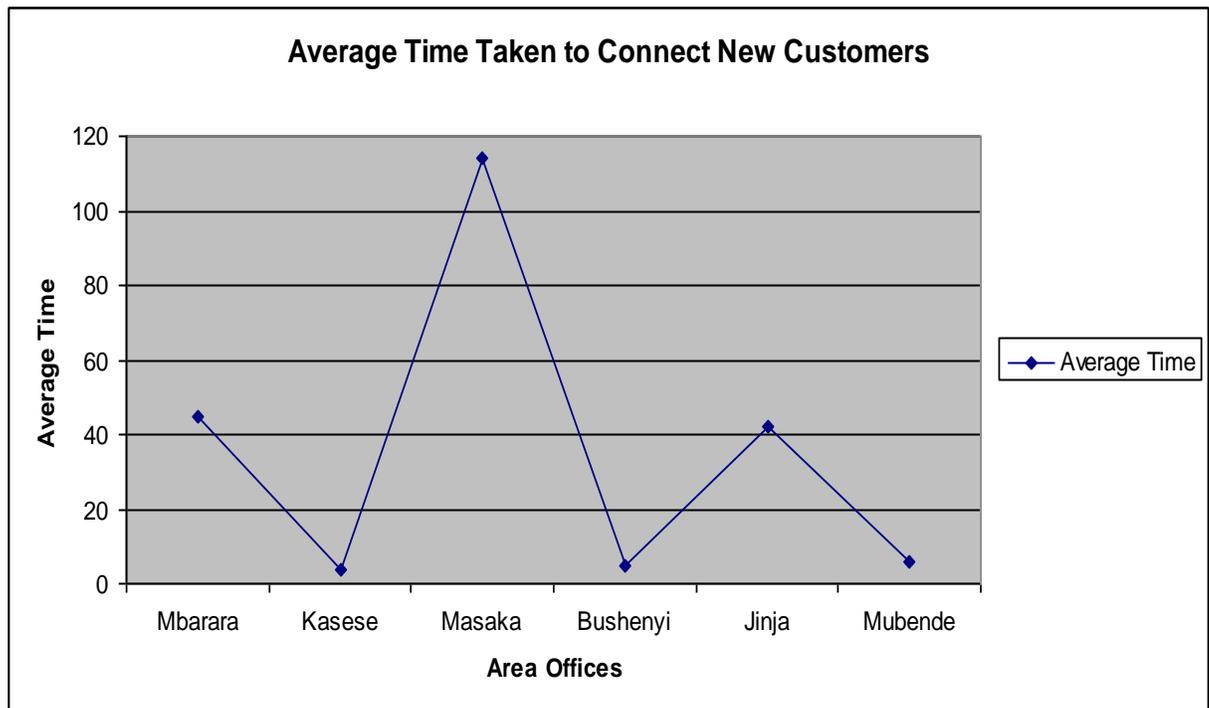
We noted however that connecting new customers takes a period ranging from 4 days to 114 days. Details are shown in the graph below.

From the above graph, Areas like Kasese, Bushenyi and Mubende takes less than ten days to connect new customers. This is mainly because the towns are relatively smaller than Mbarara, Masaka and Jinja where the customer applications are relatively more.

- (v) To minimize the delays when connecting new customers, NWSC should put in place a requirement for prospective customers to obtain authority from neighbors when applying for new connection. Sensitization of existing and potential customers, local leaders, and landlords is vital in enhancing the distribution network and supply of water to the urban population.

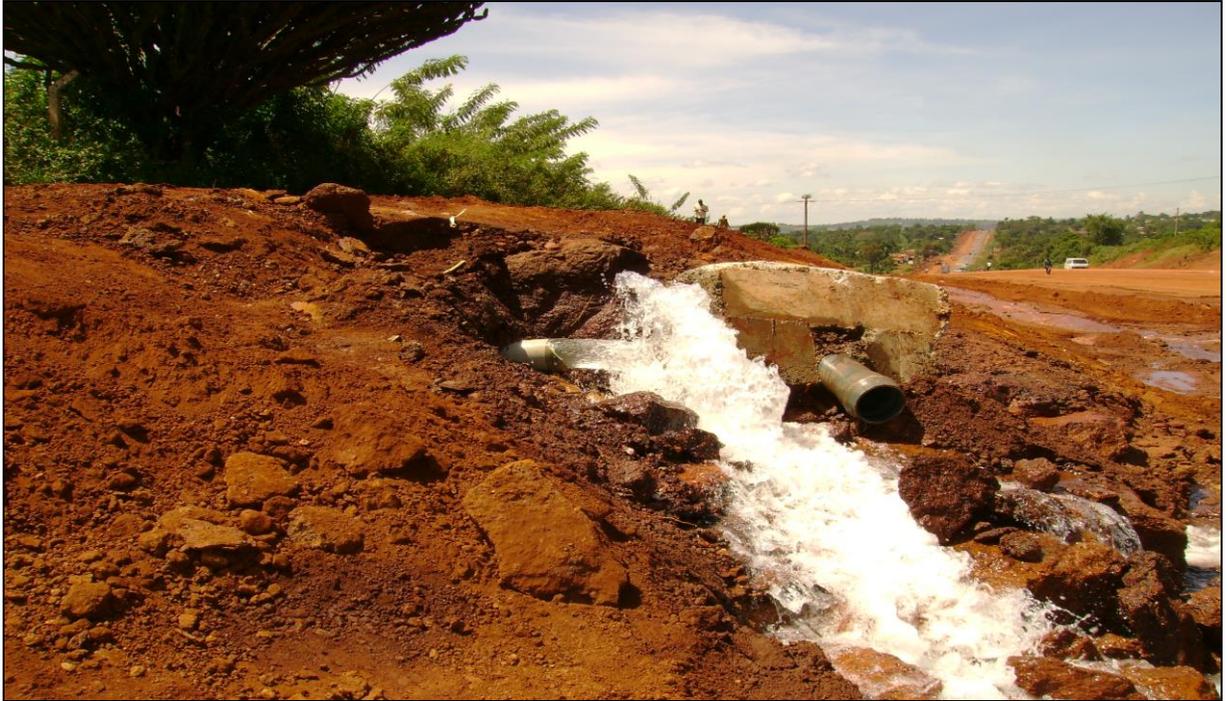
We noted that there was lack of coordination and understanding between the Corporation and various stakeholders like municipal/urban authorities, telecom companies, road contractors and individuals when laying infrastructure of different projects which require excavation work.

This arises mainly because of limited sensitization of stakeholders about the location of water infrastructure and access of premises during expansion of the distribution network.

Above: A 6 inch pipe on the mains at Wairaka (Jinja-Iganga Road destroyed during road construction). Taken on 14<sup>th</sup> November, 2007 at 11:35am

The Corporations' existing facilities have also been damaged by new excavations by other utility and service providers such as when road works, telecom and electricity cabling are taking place. The Corporation ultimately loses a lot of water when water mains are cut resulting into water shortages in urban areas like the example of Wairaka above.

- (vi) NWSC should play a leading role in steering coordination and liaising with urban authorities and other stakeholders to ensure that a coordinated plan for all developments is discussed and understood by all players to minimize damages to the infrastructure.

- Measures aimed at improving stakeholder coordination at planning and implementation of NWSC development projects should be put in place to ensure that the roles of the various players are properly executed and expectations are met. In this regard, NWSC should play a leading role in steering coordination and liaising with urban authorities and other stakeholders to ensure that a coordinated plan for all developments is discussed and understood by all players to minimize damages to the infrastructure.

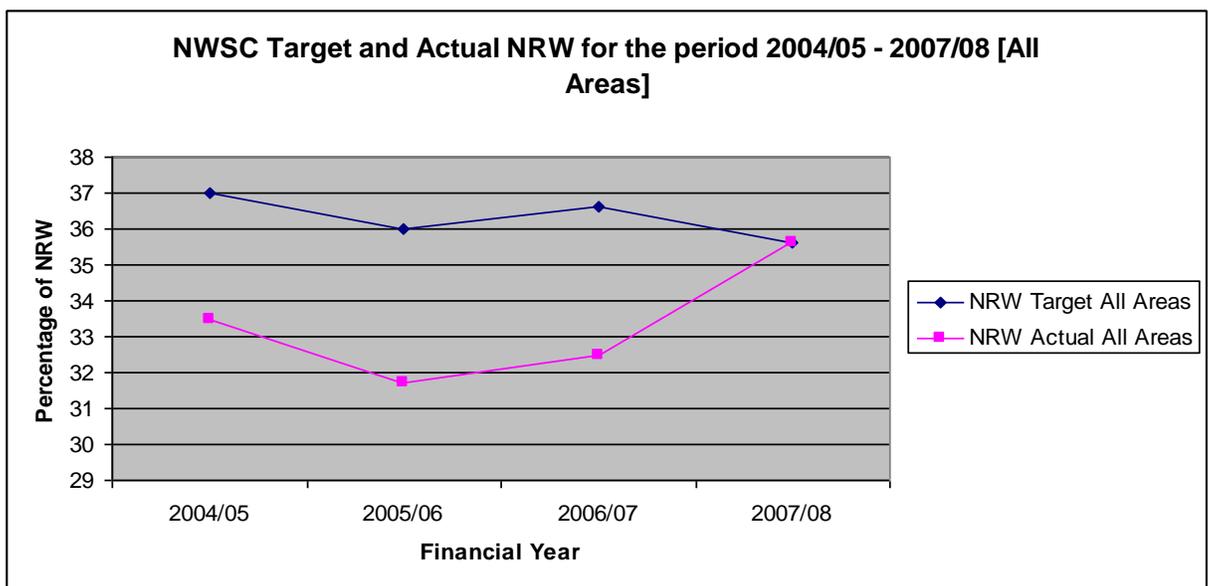
The NWSC Corporate Plans 2003-2006 and 2006-2009 set targets of NRW (shown in the graphs below) as a percentage of water produced. The first graph shows the performance of NRW for all areas while the second graph highlights the performance of Kampala alone.

While NWSC achieved the set targets, the actual NRW performance is gradually increasing and by the end of December 2007, it had reached the level of the set standard.

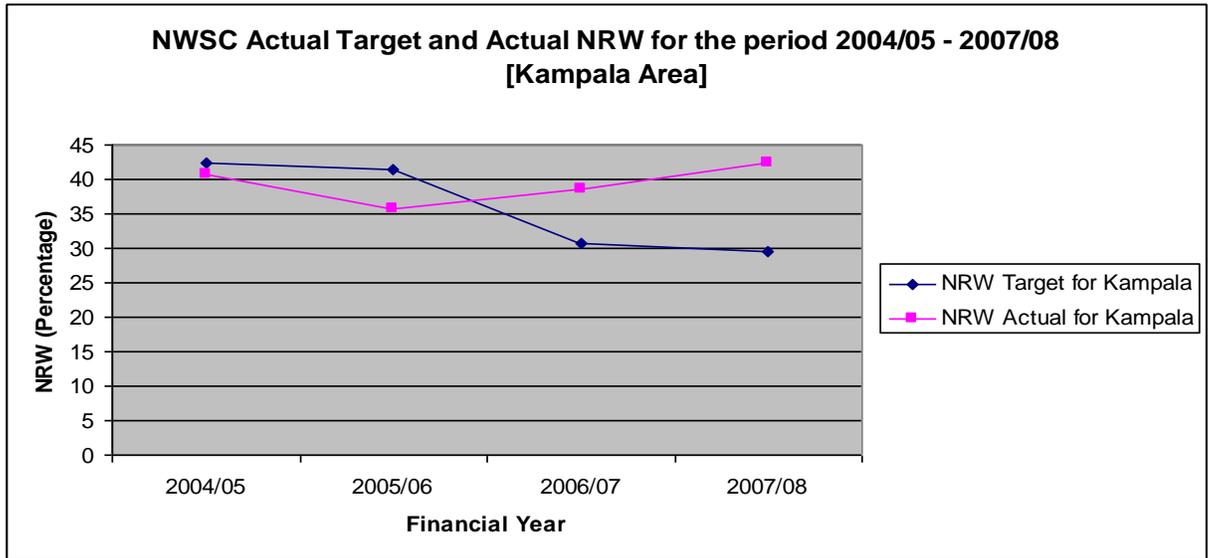
For Kampala Area, the set targets were not being achieved for the period 2006/07 and 2007/08 as shown below.

The amount of water lost through NRW is still high and exceeds IWA acceptable standards for developing countries.

The above losses are mainly caused by leakages and bursts, illegal connections, under-registering meters, water used for fire fighting, old distribution network and overload on service lines.
